Manhole Inspection Summary

Manhole # S13CC_043MH

Insp Date: **2/25/08 1:45 PM**

Location Address: **2902 RIGGS AVE** Cross Street: **POPLAR GROVE ST**

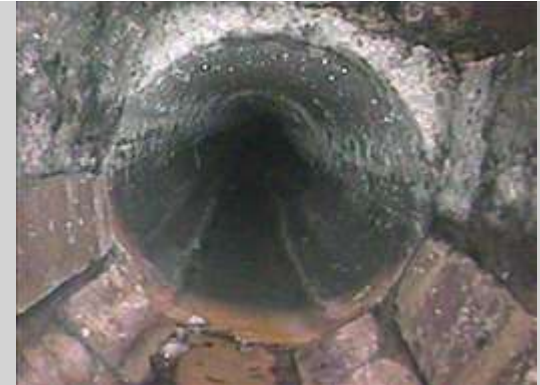
12 O'Clock Outflow

8 in. Circular Gravity Sewer
Pipe Out @ 12 O'Clock

Pipe Material: **Clay** ☐ Pipe Lined

Invert Depth: **8.50** (ft.) Flow Characteristics: **Slow**

Deposits: ☐ None ☐ Mud ☐ Sludge ☐ Debris ☒ **Grease**

Silt Depth: **0** (in.) Deposits Extent: **Light**

Infiltration: **None** Pipe Seal Cond: **Sound**

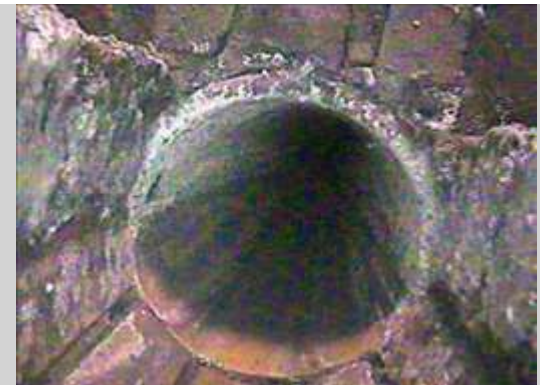
8 O'Clock Inflow

8 in. Circular Gravity Sewer
Pipe In @ 8 O'Clock

Pipe Material: **Clay** ☐ Pipe Lined

Invert Depth: **8.48** (ft.) Flow Characteristics: **Slow**

Deposits: ☐ None ☐ Mud ☐ Sludge ☐ Debris ☒ **Grease**

Silt Depth: **0** (in.) Deposits Extent: **Light**

Infiltration: **None** Pipe Seal Cond: **Sound**
